4-Point Inspection Form

Address Inspected: 6153 County Road 352, Keystone Heights, FL 32656

Actual Year Built: 1960 Date Inspected: 03/30/2023

Moore Property Inspections, Inc. 03/30/2023

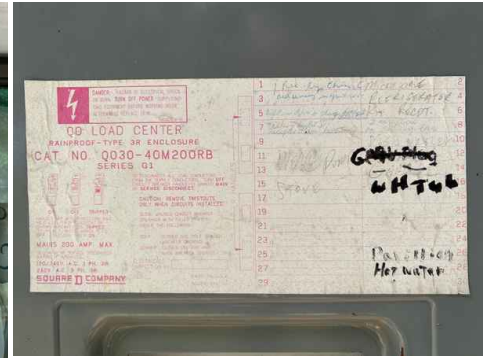
Main Panel Label

Panel age: 38 years

Year last updated: 1985

Brand/Model: Square D

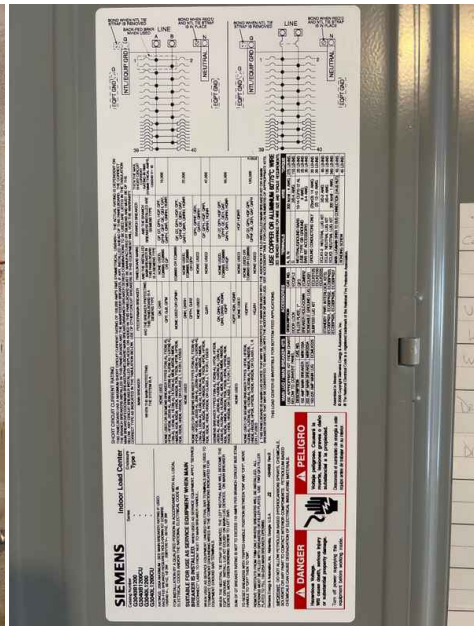
Second Panel Label

Panel age: 15 years

Year last updated: 2008

Brand/Model: Siemens

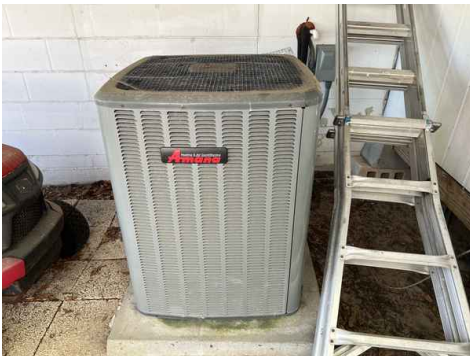
AC Condenser 1

Additional Comments/Observations(use additional pages if needed):
 AC Condenser and Air Handler 1 were manufactured in 2008 and are 15 years old. AC Condenser and Air Handler 2 were manufactured in 2016 and are 7 years old. The front section of the roof was updated with new metal panels in 2014. Water Heater 1 Age 15 years old, Water Heater 2 Age 43 years old, Water Heater 3 Age 10 years old. Roof age estimated off of historical satellite images.
